Manhole Inspection Summary

Manhole # S35UU1005MH

Insp Date: **2/5/07 10:23 AM**

Location Address: **5234 DOWNING RD**

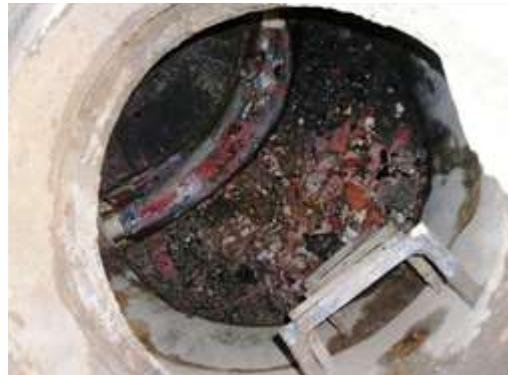
Top View

Bench debris.

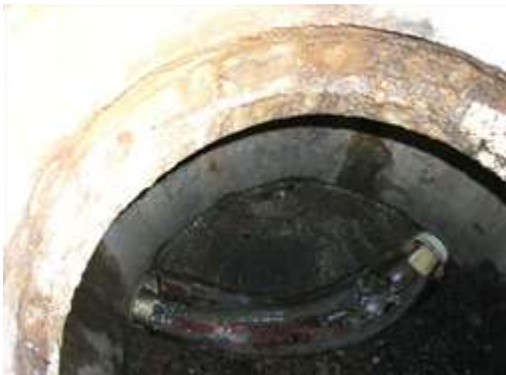
Defect

Frame leaks. Adjustment and Barrel infiltration - other side.

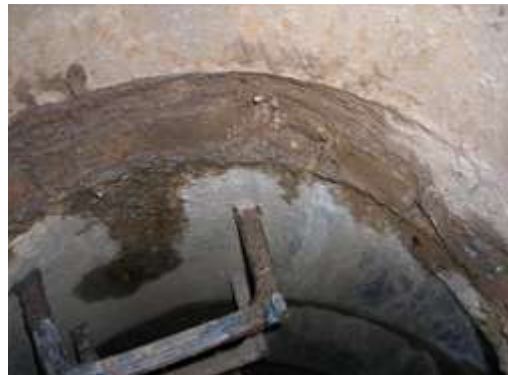
Defect

Frame leaks. Adjustment and Barrel infiltration.

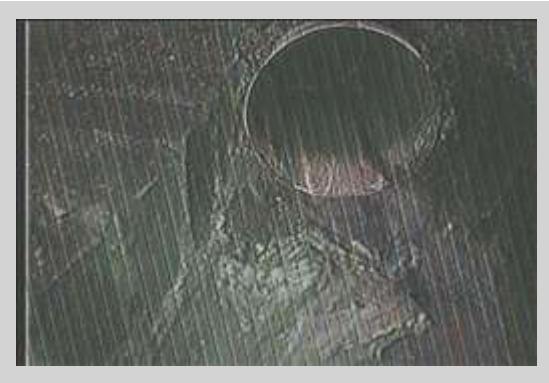
8 in. Circular Gravity Sewer Pipe Out @ 12 O'Clock

Comments **The O12 pipe picture shows Channel debris.**

Infiltration: **None** Pipe Seal Cond: **Roots**

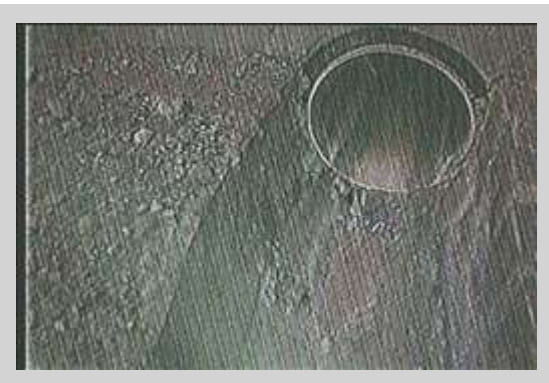
8 in. Circular Gravity Sewer Pipe In @ 8 O'Clock

Infiltration: **Evidence** Pipe Seal Cond: **Unknown**
